REPORT NOS. DOT-TSC-NHTSA-79-30

✓
✓
DETERMINATION OF TIRE QUALITY.
FROM NONDESTRUCTIVE INSPECTION

U.S. DEPARTMENT OF TRANSPORTATION
RESEARCH AND SPECIAL PROGRAMS ADMINISTRATION
Transportation Systems Center
3 Cambridge MA 02142

NOVEMBER 1979
FINAL REPORT

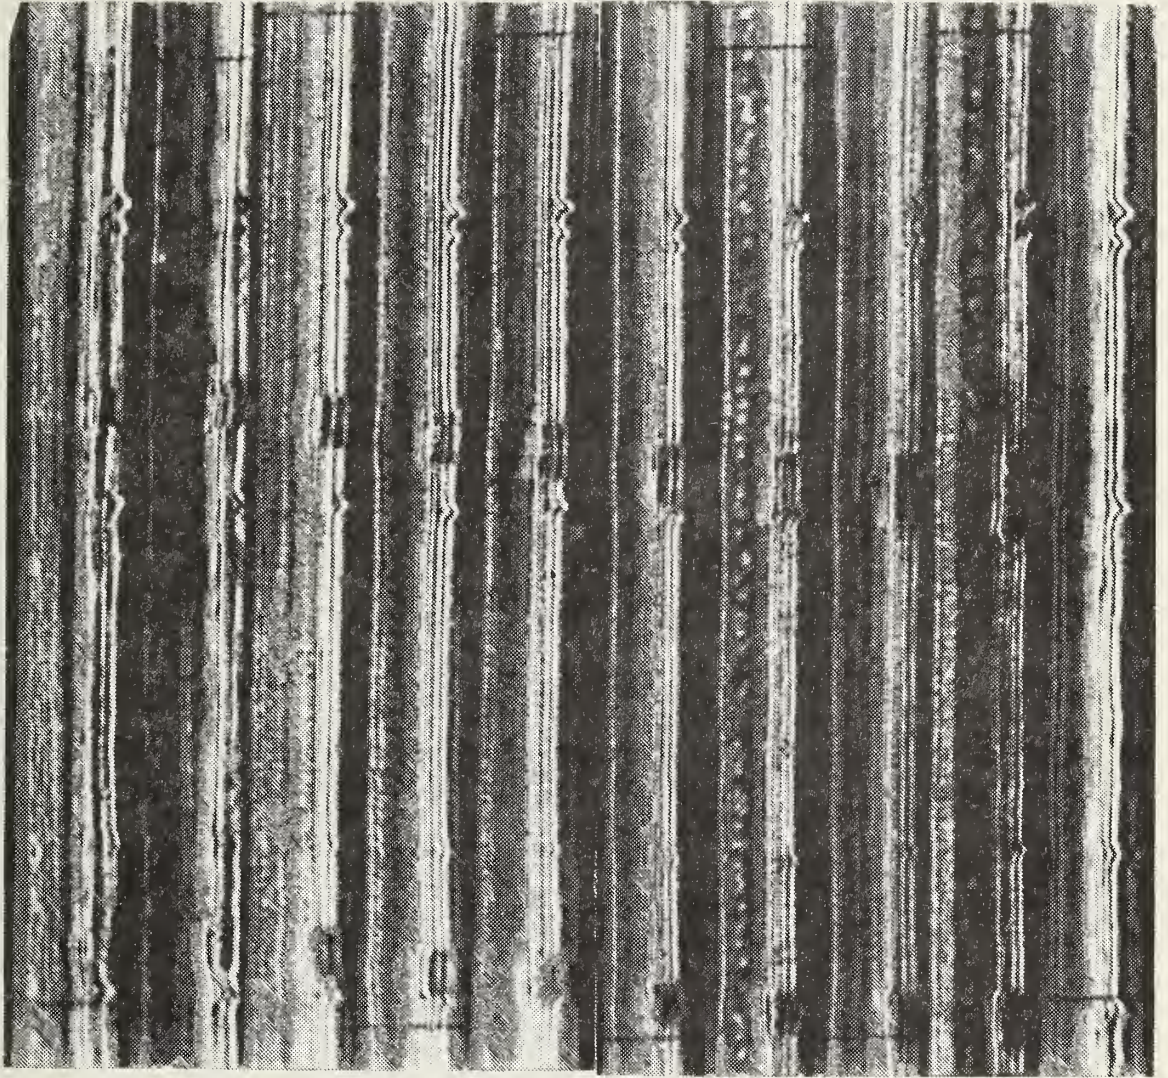
FIGURE 4-1. PRINTOUT OF UNIROYAL

Uniroyal. Construction of Uniroyal and BIG-O (also made by Uniroyal) is two-ply polyester, two steel belts, and a nylon breaker over the belts. The purpose of the breaker is to hold the belt edges down and prevent belt edge separation. This is Uniroyal's premium tire and as far as is known has performed over a number of years in a satisfactory manner on the Compliance Tests and in road service. It is manufactured under a proprietary process involving automatic builders. These builders leave an exceptionally long splice on the belts and this long splice plus the force exerted by the nylon breaker leaves an ultrasonically dense region in the splice area. This region is shown in Figure 4-1 as a typical singularity/shadow system as defined in Appendix A. For this reason the Uniroyal grades are lower than performance indicates.
